MAGNT RESEARCH REPORT No. 10
JANUARY 2005

THE HISTORIC SHIPWRECK *SS BRISBANE* (1874-1881)

A PLAN OF MANAGEMENT

DAVID STEINBERG

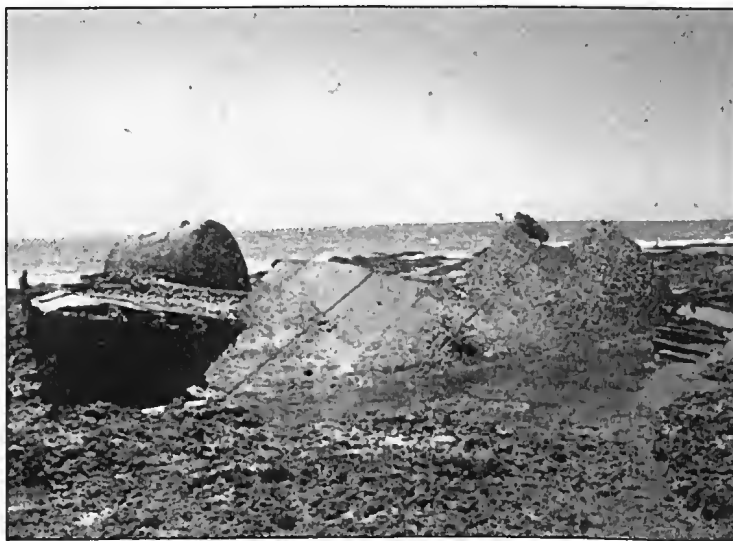
Fig. 14. Bow (photo: D. Steinberg)

The bow. The section of curved bow is one of the most recognisable structural features of the wreck and it is located in the intertidal zone or what can be described as the higher plateau of the reef.

An observation of the wreck was made in 1881, the year it stranded, in which it was stated that the ship was tilted at an angle sufficient to make a length of the bow hang above the ground. Perhaps this section of bow viewed on the reef today constituted a part of the bow that hung above the reef. Eventually, under its own weight, the bow would have broken away from the keel of the ship and fallen to the ground.

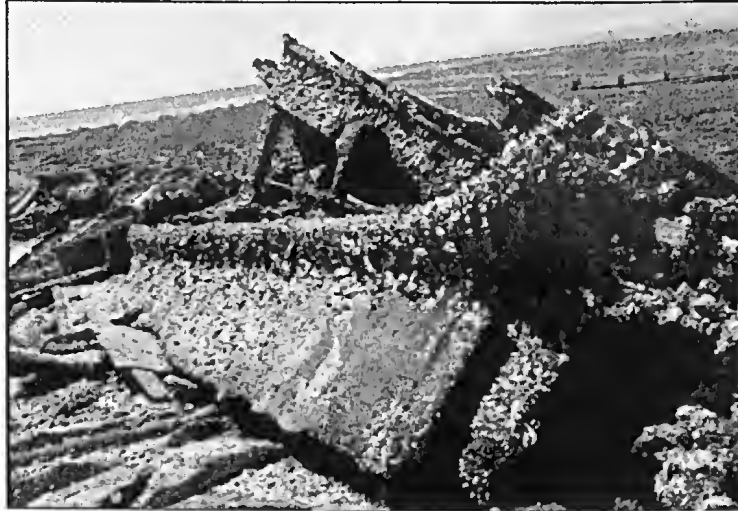
Fig. 15. Keel or stem post (photo: D. Steinberg)

The keel or stem post. A long iron structure lies wedged into the bow section. It appears as two blade shaped lengths of sheeting joined together by a thick length of iron. It is either a section of the keel or stem post. It is more likely a portion of the keel, with both sides of the ship's outer hull still attached. There is not a keelson attached to this length of keel to support this argument. However it is less likely the stem post because a section of stem post attached to the bow is of a different thickness and width.

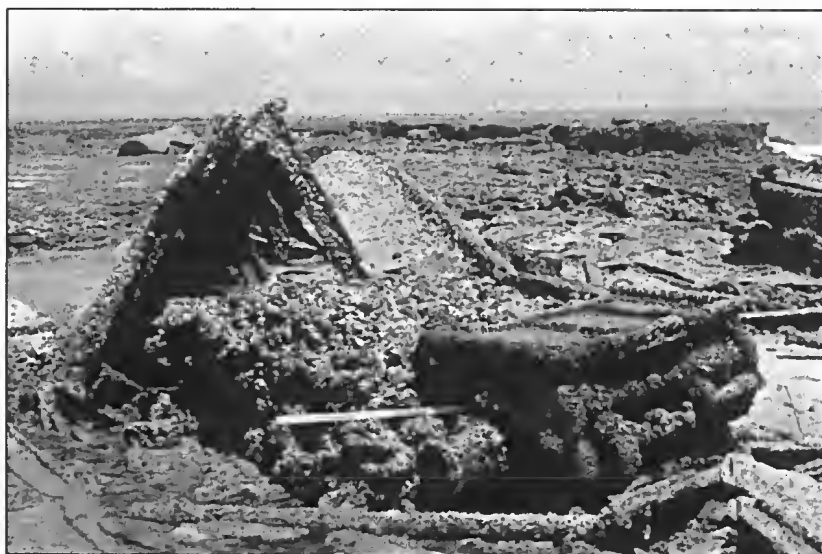
Fig. 16. Winch and chain (with bow in background) (photo: S. Jung)

Directly behind (west) of the bow structure is a winch, a large mound of chain and a short section of the foremast. Although they are in close proximity to each other the chain itself is not wound onto the spool of the winch. It is unlikely that this winch was used to haul this chain as the windlass was better suited for that work. The winch sits upside down. The chain is a solid mass fused together by corrosion. It was once stored inside a sub-deck forward chain locker, however there is no evidence of the locker fixed or corroded into this mass of chain. The section of mast must have been torn away from the rest of the foremast by a sudden physical action rather than slow progressive corrosion. It is unlikely that its present location demonstrates where the foremast originally collapsed.

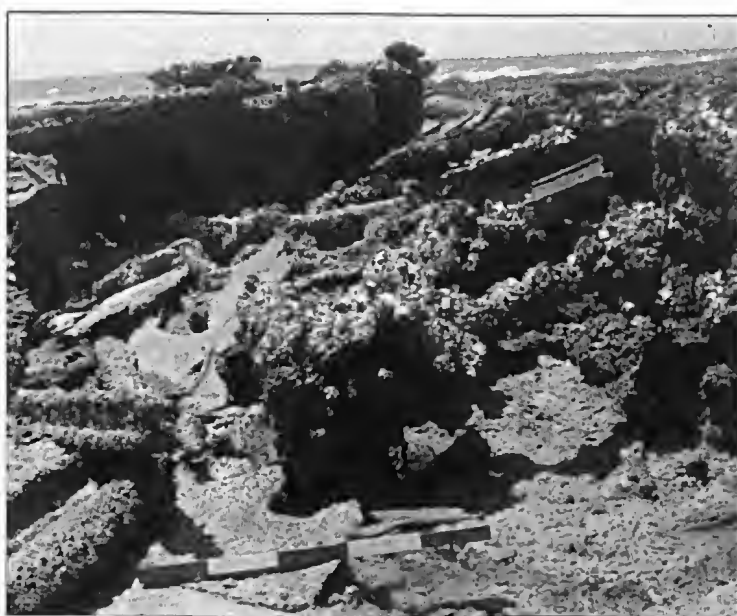
Fig. 17. Capstan and davits (in foreground) (photo: S. Jung)

Davits and Capstan. Just forward (east) of the bow by a few metres are four boat davits and the capstan. Davits were the small hook-shaped cranes that were used to secure and lower the ship's boats and raise the anchors from the hawse to the deck. The capstan was a large spool which sat on the forward deck and guided the chain to and from the locker. The capstan's shaft has been broken along its length, however the heavier and stronger capstan spool still remains attached to the shaft.

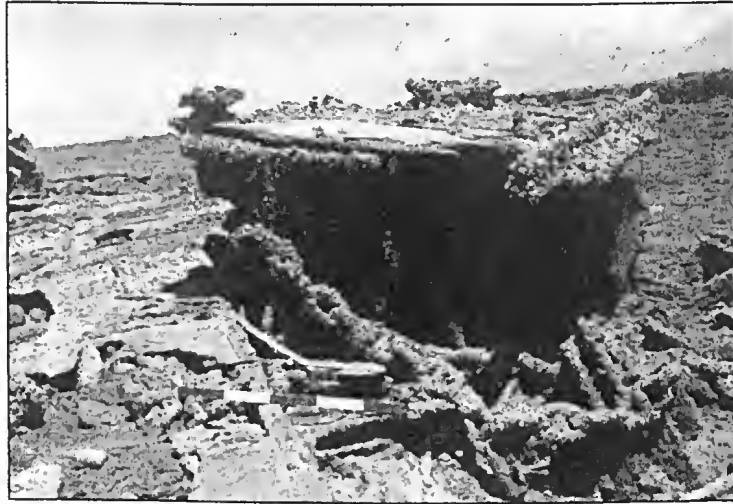
Fig. 18. Windlass (photo: D. Steinberg)

Also located close to the bow is a windlass, which, like the smaller sized winches, was a steam driven pulley. It can be recognised as a windlass because it is substantially larger than the two remaining winches and it has a length of chain which leads to a bower

anchor. Paasch (Paasch 1977:156) distinguishes a windlass from a winch by its role in heaving bower anchors. The windlass sits upside.

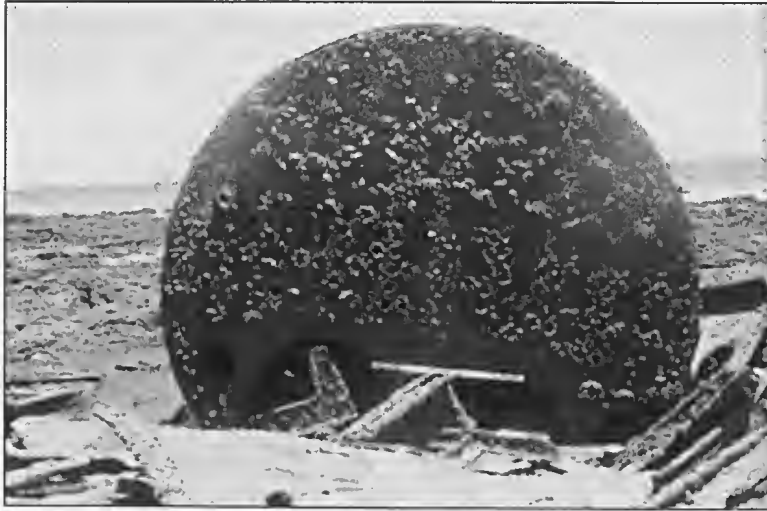
Fig. 19. Main boiler face (photo: D. Steinberg)

This particular boiler had been moved over 20 metres from its original deposition by wind and wave action. The boiler has been rolled in an easterly direction, suggesting that it was extreme north-west monsoonal weather that moved it.

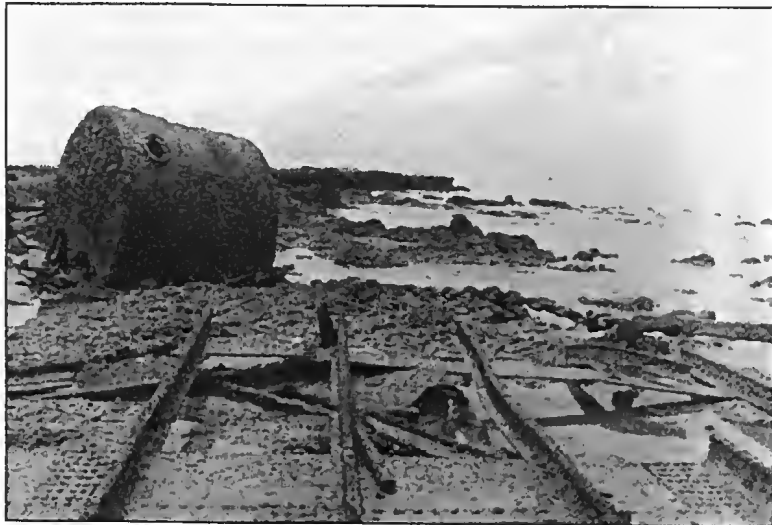
Fig. 20. Main boiler and deck debris (photo: D. Steinberg)

Figure 20 shows structural debris that is most likely the remains of deck flooring opposed to hull structure. The deck debris appears as iron sheets riveted to a framework of supportive beams. There are regular rectangular spaces which were either hatches through the floor or areas covered with teak decking.

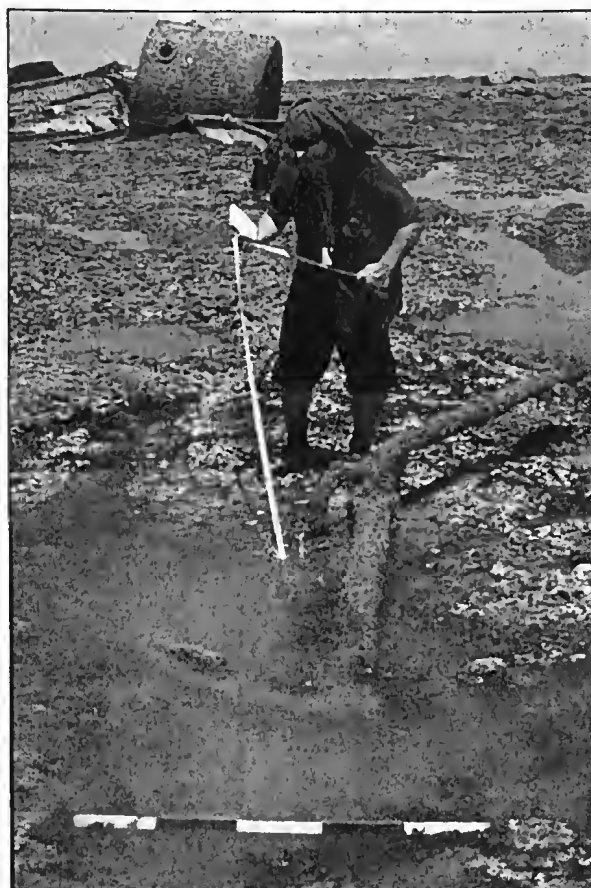
Fig. 21. Stream or ketch anchor (photo: S. Jung)

Figure 21 shows the smaller of the two complete anchors, which is either a stream or ketch. Note that this anchor has a ring at the end of the stock but no chain connected. Also one end of the stock has been broken off and the other end twisted back.

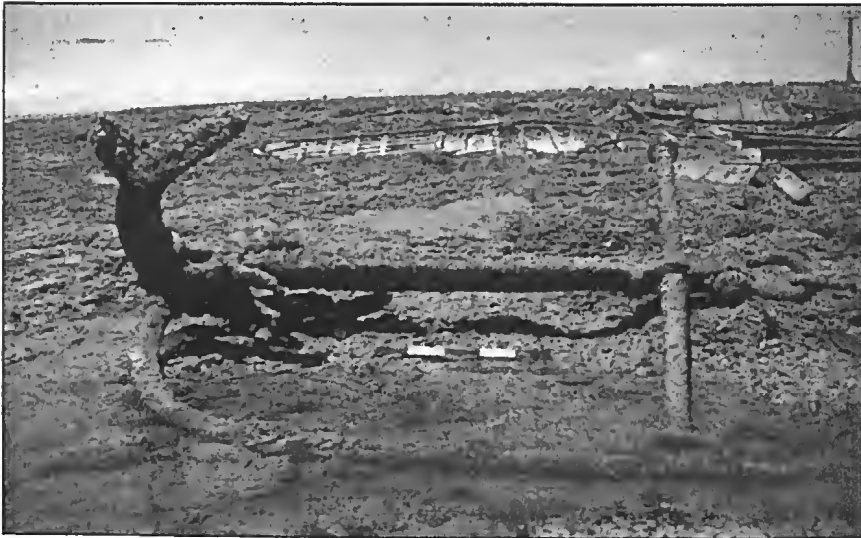
Fig. 22. Larger bower anchor with davit (photo: S. Jung)

The bower has a large fluke that is bolted to the shank. Along the length of the shank (on both sides) is a fish-shackle, used to secure the anchor on deck. The anchor has chain attached and this chain leads to the windlass. It is unclear whether the anchor was deliberately thrown overboard once the ship became stranded or if it fell as part of the bow breaking up.

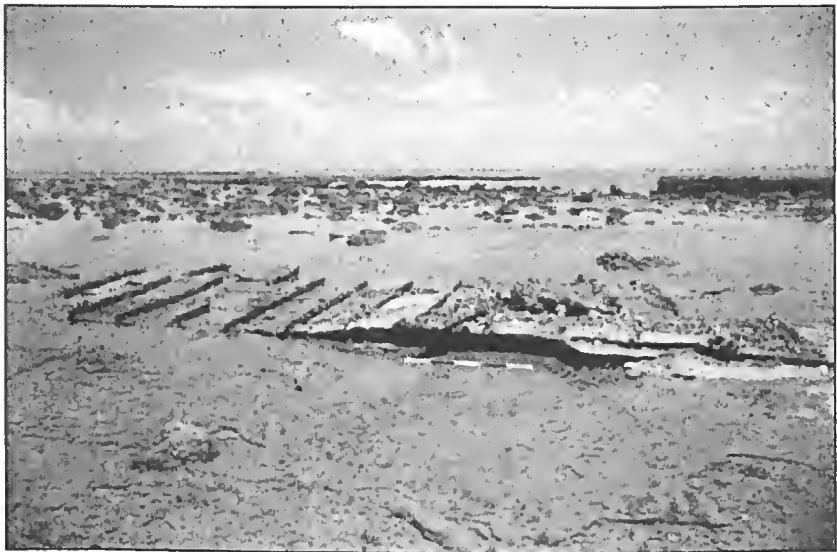
Fig. 24. Sections of hull east of the bow (photo: D. Steinberg)

Some of the hull sections show the internal rib structure face up. Other examples have the outer side exposed. A section of gunwale with a bollard and a portion of deck are also located in this area.

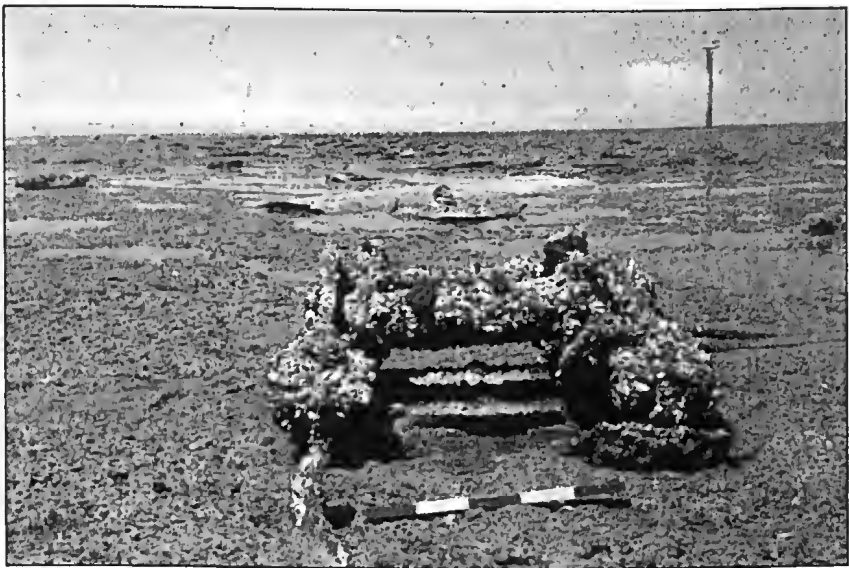
Fig. 25. Winch (photo: D. Steinberg)

The image below shows the winch located east of the bow, and its position in relation to the navigation beacon. The winch is heavily encrusted with marine growth, unlike other features such as the boilers. The diagnostic features that identify this feature are the squat frame, the warping ends (spools), wheels and horizontal rods.

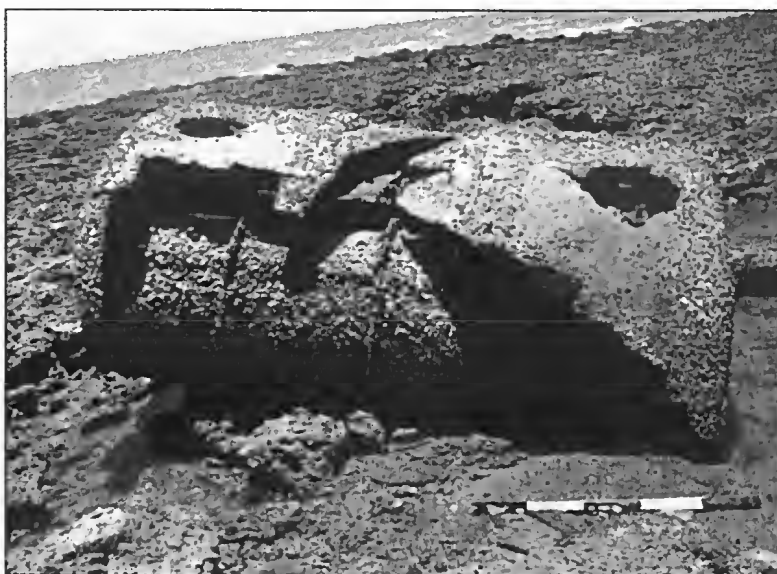
Fig. 26. Donkey boiler (photo: D. Steinberg)

The donkey boiler located south-east of the bow is shown below. Its outer plating has in places been torn away and so the two cylindrical chambers are visible for inspection. Neither furnace doors or control levers remain on this boiler.

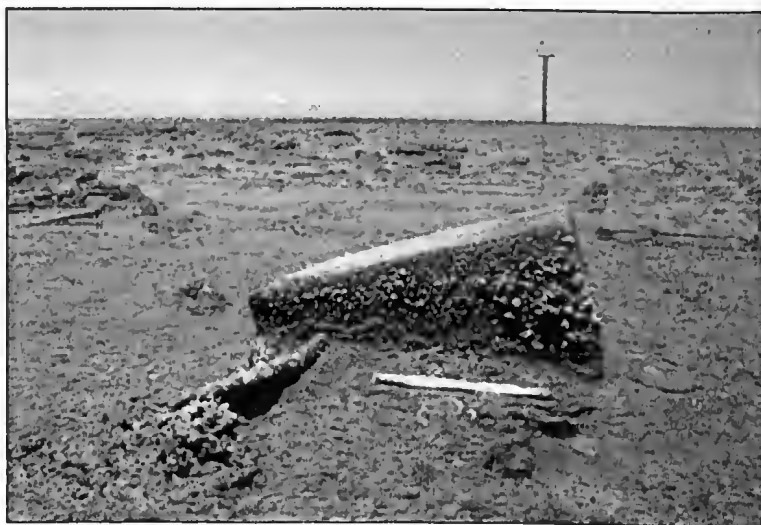
Fig. 27. Storage tank (photo: D. Steinberg)

One rectangle shaped tank is located approximately 50 metres east of the bow. The oval hatch door of the tank is absent and two inlet/outlet valves are located on the same side. The dimensions of this storage tank are 1.2 metres x 2.3 metres. It is partly buried, making it difficult to measure a height (or thickness).

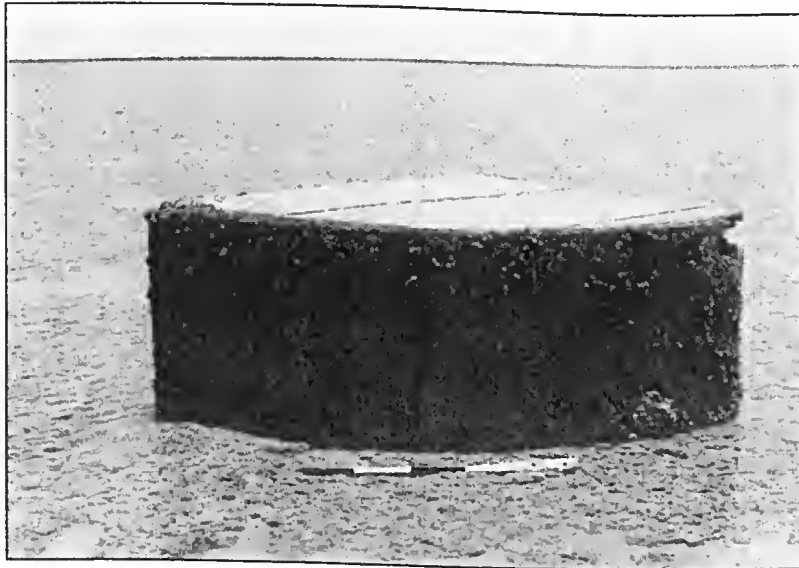
Fig. 28. Curved storage tank (photo: D. Steinberg)

A second tank is located approximately 300 metres from the bow in a south-south-east direction. This tank is wedge shaped suggesting that it was built to fit into a wedge shaped cavity, for example the forward curvature of the bow. Interestingly, the top surface, as it lies on the reef, is made of three overlapping sheets. This may have been a technique to increase surface strength. The length of each of the perpendicular sides is 1.63 metres. The width (height) of the tank is 80 centimetres in length.

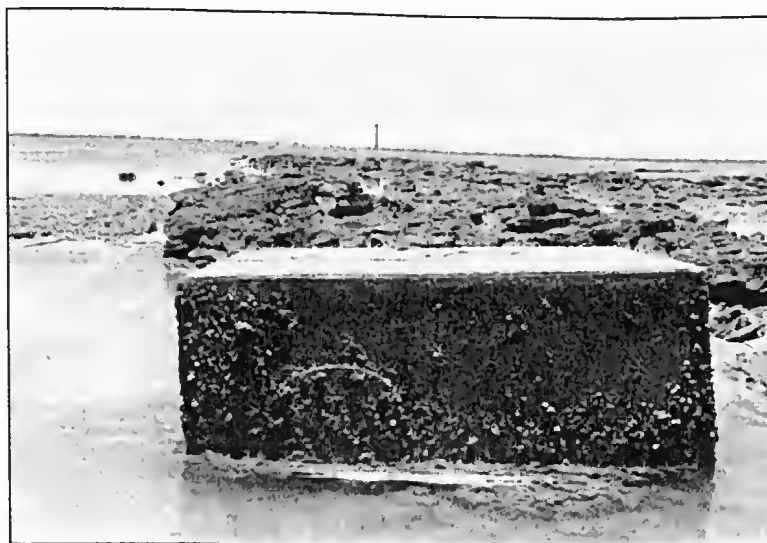
Fig. 29. Larger storage tank with beacon in background (photo: S. Jung)

A third storage tank is located over 400 metres away from the bow in a south-east direction. This tank is rectangle shaped and measures 1.96 metres x 2.30 metres x 0.83 metres. The larger tank surfaces consist of iron sheets fixed side by side, rather than in an overlapping style. Unlike the smaller rectangle shaped storage tank described earlier, the oval hatch is sealed shut.

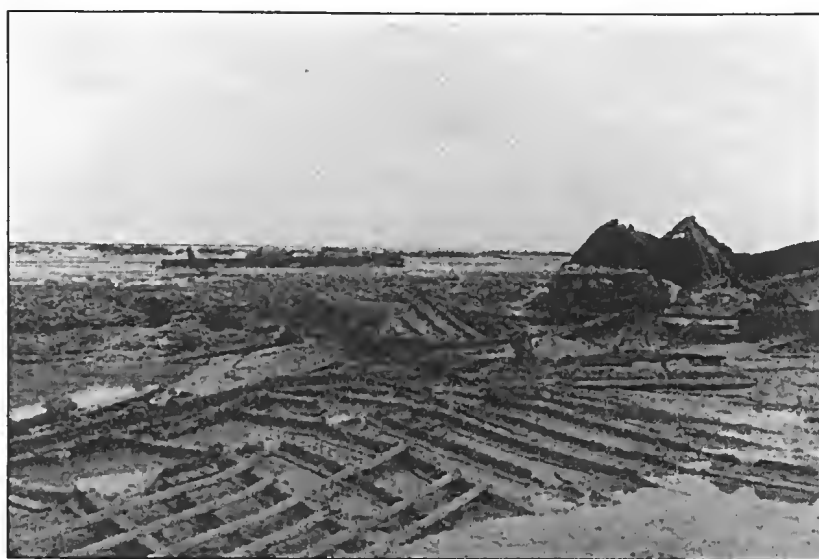
Fig. 30. Hull debris aft of the bow

It is logical that this section of the wreck, over the stern section, has been broken up and scattered, as this area of reef experiences the full force of breaking waves and strong north-west winds.

Figure 30 shows the greatest concentration of hull plating in this area.

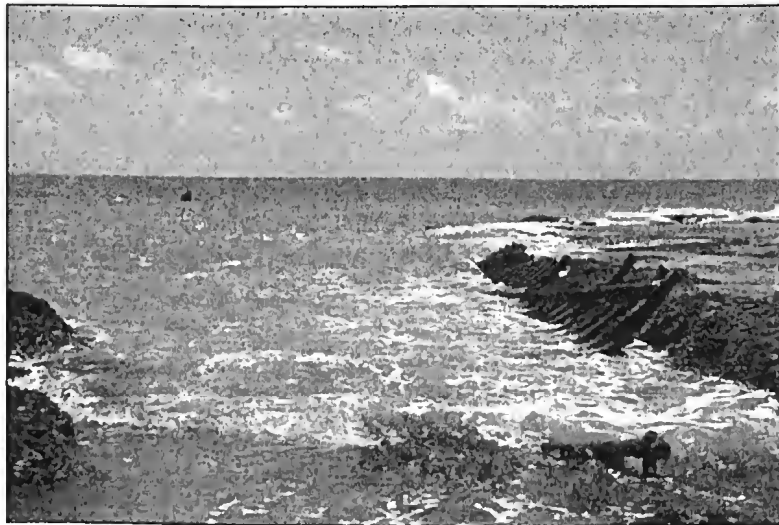
Fig. 31. Exposed ribs and stern steering mechanism (photo: S. Jung)

Figure 31 shows the water's edge at a spring low tide. A stock of an anchor and the rib structure of the lower port side are visible in the foreground. In the background the stern steering mechanism protrudes from the water. The anchor stock to the stern steering mechanism clearly marks a specific section of the shipwreck. This section constitutes what was the stern to the midships of the *SS Brisbane*. This wreckage is not only a separate section of the shipwreck, because it is located below the low tide mark and therefore only accessible through scuba diving. It is also useful to consider it separate because the degree of hull integrity here differs greatly to that seen in the rest of the site.

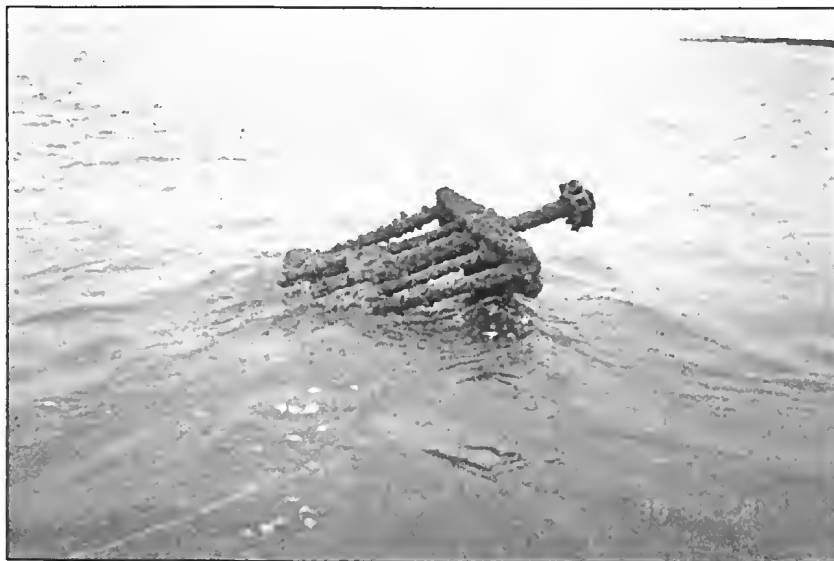
Fig. 33. Steering mechanism attached to stern post (photo: P. Clark, 1990)

As the drawing suggests, the propeller and rudder are still attached to the stern. The propeller is four bladed and made of iron. The rudder is turned to starboard. As demonstrated on the diagram, there is no stern wheelhouse on the wreck. The tallest feature of the stern is the stern steering mechanism, which is attached to the sternpost. The steering crank was once attached to an aft wheel, which was likely used only if the primary mechanism failed. Below the steering mechanism there are a few beams attached to the sternpost. These are likely remains of the transom structure. Figure 33 shows the stern steering mechanism.

The stern appears to have broken away from the hull just forward of a bulkhead. The walls of the stern are intact from the deck to the keel. The stern's surface has both areas covered by iron deck and areas without deck, the latter allowing the inner workings of the stern to be seen. This is the far rear section of the stern and so the space within the stern is small and tapered. Protruding from the forward end of the stern is a length of the propeller housing and shaft.
